Suter ENGINEERING, PC

July 8, 2016

Re: Site visit and survey of Mechanical Systems
Shenandoah Valley Electric Co-op, Mt Crawford, Virginia

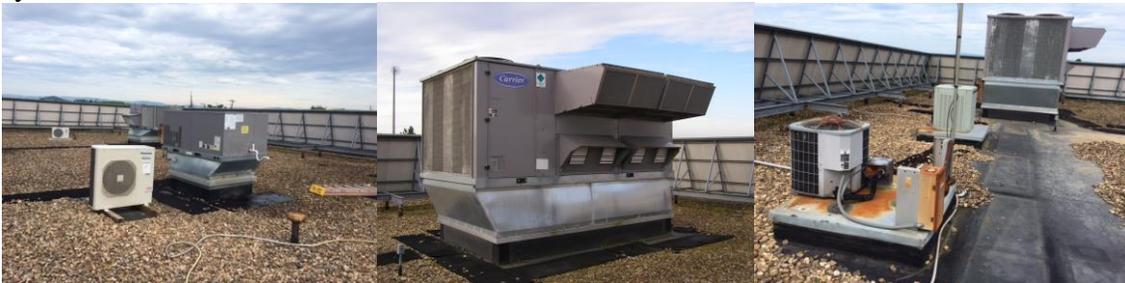
The Hvac system consists of 5 Roof top units (RTUs), 3 split systems and 2 ductless split systems.

The two large and main RTUs are set up for variable air volume (VAV) with approximately 17 VAV boxes and 11 fan powered boxes that serve the engineering wing and the accounting wing. All of the VAVs are equipped with electric re-heat. The three smaller RTUs serve the front office & waiting area, the conference rooms, server room and corridors. All five RTUs are straight AC with electric heat. The RTUs range in capacity from 5 tons to 25 tons with a total capacity of approx. 89 tons of cooling for this building including all the split systems. The three split systems serve the operations room, the utility room and possibly the kitchen. The ductless split systems serve a large office and the other ductless unit serves as back-up to the server room RTU. Also included in the existing Hvac system are 13 exhaust fans, 50 convection heaters and approx. 6 other misc heaters serving utility type rooms.

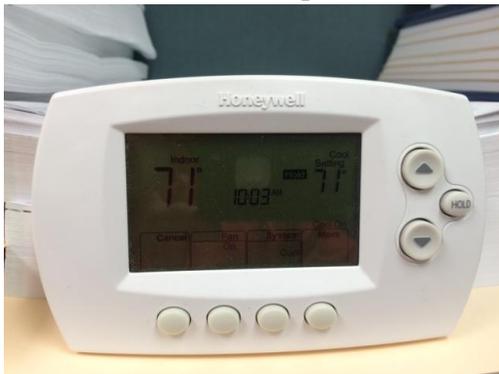
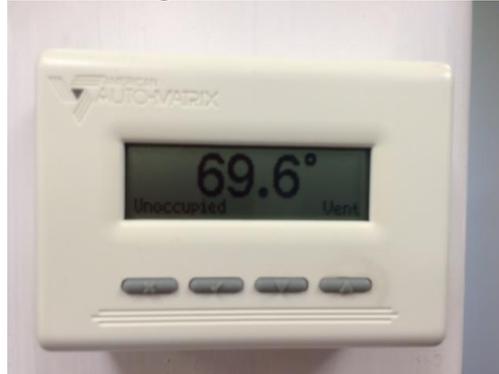
In about 2005 or 2006 the 5 RTUs were replaced. The Trane RTUs were replaced with Carrier brand. At the time of the RTU replacement, the thermostats and control system were replaced with a lite-commercial control system. All the 17 VAV boxes, 11 fan powered boxes stayed as-is and are original and 27 years old now. Of the three split systems, only one looks original, but they all look like 1988 – early 90s vintage. The main RTU thermostats and most of the control system were replaced recently. The new thermostats are high quality Honeywell commercial thermostats. The individual office thermostats were not replaced but seem to be working fine.

The ductwork is commercial grade and installed in a professional manner. The ductwork and VAVs look good. I understand that the lite commercial controllers on the VAVs were recently replaced when the thermostats/controls were replaced.

So the five main RTUs are only 10 years old and one of them is only 1-2 years old (Server Room). The controls are only a few years old and good quality. The ductless systems appear to be in good shape and not very old. The three split systems look to be 25-27 years old and past their life expectancy. I recommend that if any of this equipment fails before the new owner takes over, that the Hvac equipment is replaced with like kind and like quality.

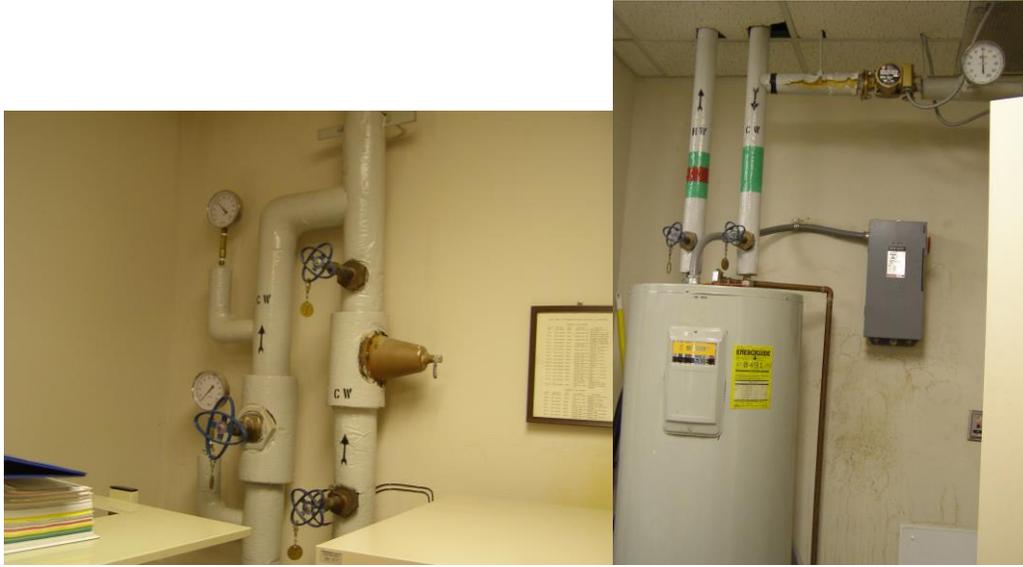
The existing plumbing looked to be of a high commercial standard. The existing piping and fixtures are all excellent quality. The existing domestic water main appears to be a 3" supply line that enters the building and then reduces to a 2 ½" CW supply. This 3" to 2 ½" supply is sufficient for some additional bathrooms or fixtures if desired.

Additionally the county water system provides good pressure to this building as it is being reduced to 70 psi operating pressure. The existing 80 gallon hot water heater with recirc loop and recirc pump provides good hot water service to all parts of the building.
